# Issue xx DC Input Disturbance Faults and Solutions

Every PV plant will have unique challenges. In this Solis Seminar episode, we will focus on a common fault in photovoltaic systems: DC Input Disturbance, and its solutions.

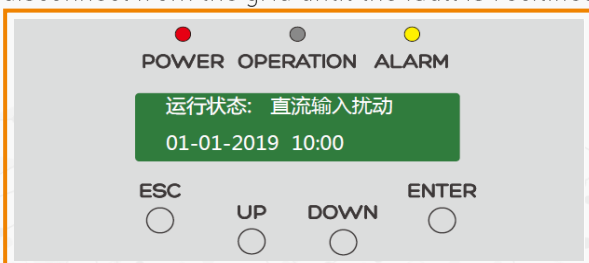
Within the PV system, if the DC side is abnormal, the inverter will display a "DC INTF" alarm when it starts running. If this fault occurs, the inverter will disconnect from the grid until the fault is rectified.

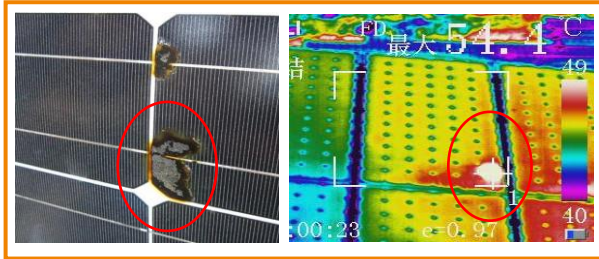
**Cause 1:** There is a problem with the PV modules.

**Solution:** Observe whether the components have hot spots or obvious damage. In addition, you can use an infrared thermal imager to check the temperature of the PV module during operation. This will detect conditions that are not easily seen by the human eye. The relevant PV module causing the fault is identified and should be replaced.

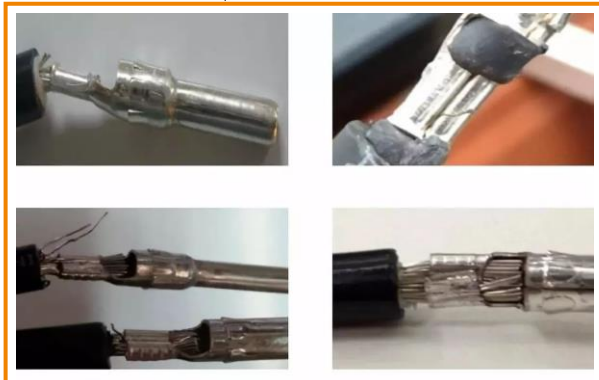
**Reason 3:** The wiring construction of the inverter MC4 DC terminal is not standardized, and make a virtual connection problem inside the connector;

**Solution:** Use an MC4 wrench to remove the DC connector and crimp the DC terminal again.

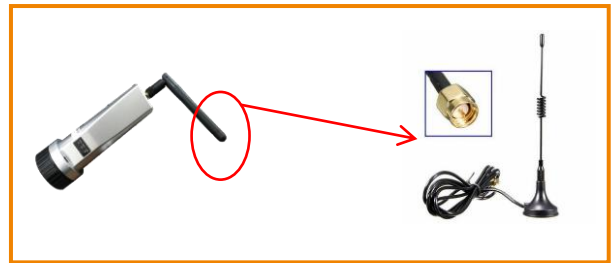
**Communication Signal Interference:** In an environment with weak signal, any GPRS/WIFI communication transmission power increase will affect the signal of the DC current sensor, causing the inverter to report "DC INTF";

**Solution:** Replace the antenna of the GPRS/WIFI stick with a suction cup antenna, and move it to another location away from the DC input terminal.

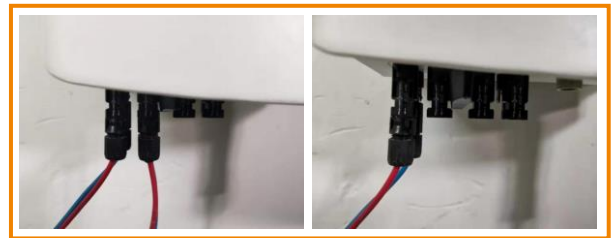
**Issues with the String or Poor DC connection with the Inverter:** If no problems are found by checking all the above-mentioned potential reasons you should check each string to identify where the error is originating.

**Solution:** Connect the strings one by one, check the inverter warning function to see if the inverter connection is correct. When the error is displayed you will have identified the string with the problem and be able to investigate further.
